Maynard Fire Station
Existing Conditions Assessment
Civil

October 12, 2015

CIVIL ASSESSMENT

Maynard Fire Station
Existing Conditions Assessment
Structural

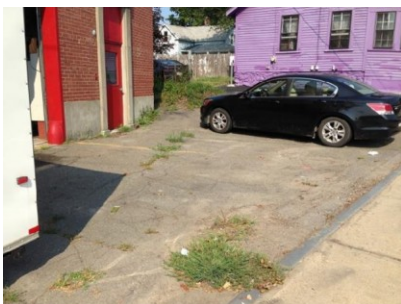
The asphalt pavement within the site is in generally poor condition with many areas of cracking and degradation (Image 11 and Image 12). There is vegetation that is coming through the cracks in many areas. Curbing on the site is of vertical concrete curb. Curbing is in general fair condition (image 13). No areas of ponding were detected during the site visit.

Image 11:
Cracks & Vegetation in Parking Lot

- Provide full depth pavement reconstruction and new parking space layout;
- Provide topographic survey and record research for existing utilities;

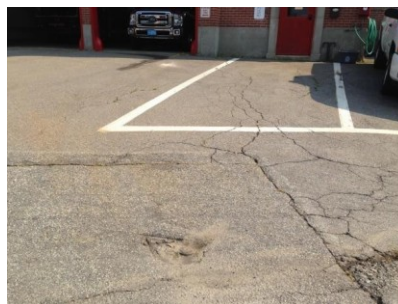
Image 12: Cracks in Parking Lot

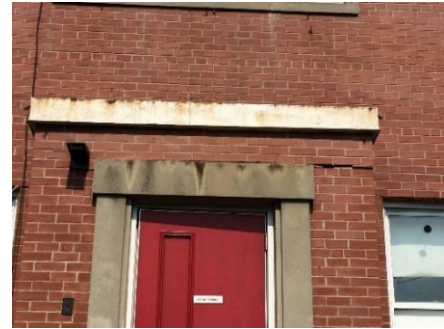
Image 5

Above the main entrance, we observed the masonry façade and noted a large horizontal crack and open mortar joint (Image 5 & 6). We also noted water staining over the head of the door. Further investigation would be required to determine the cause of the cracking. Removing the loose material and sealing the open joint is recommended to resist water infiltration and further deterioration to the façade.

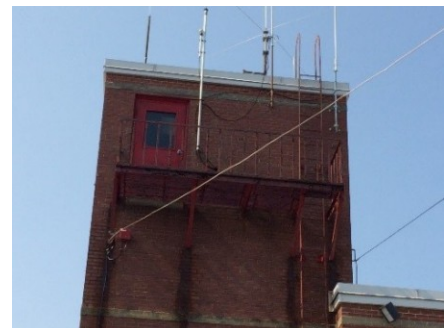
Image 7

We observed the exterior façade of the building and noted a rusting metal-framed catwalk (Image 7) and at small metal brackets which support window air conditioning units.

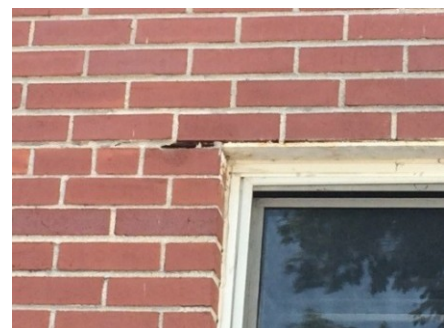
Image 8

We observed light rusting on the metal lintels above various window penetrations (Image 8). When a future renovation is planned, we would recommend cleaning the lintels with a wire brush and coating the steel to protect it from deterioration due to moisture and weathering. At the ends of the lintels, we observed open portions of the horizontal masonry joints. We would recommend routine masonry maintenance, which would include repointing joints.

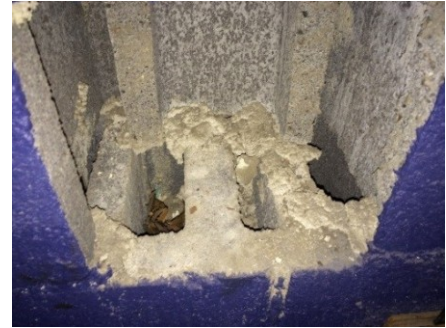
Image 9

The interior masonry partition walls essentially consist of hollow concrete masonry unit construction. We observed interior masonry partition walls and noted some damage (Image 9). From within the damaged area, we did not observe reinforcing bars, and we observed hollow cells in the masonry. We would recommend infilling the damaged masonry with new blocks and joint material to match the existing.

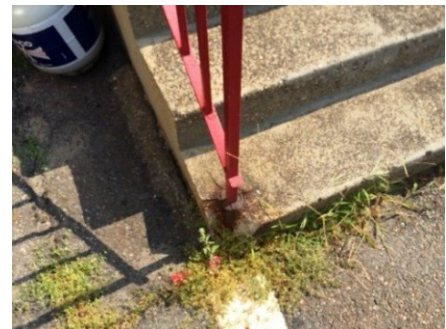
Image 10

We observed concrete stairs at the entrances and noted deterioration to the base of the railings (Image 10). We noted rust staining, delaminating steel, and cracked and spalled concrete. We would recommend repairing the base of the railing post bases, which would include welding new

baseplates and installing new anchors into the concrete. Repairing the concrete is recommended, which would include patching the spalls with a bonding agent and a cementitious patch material.

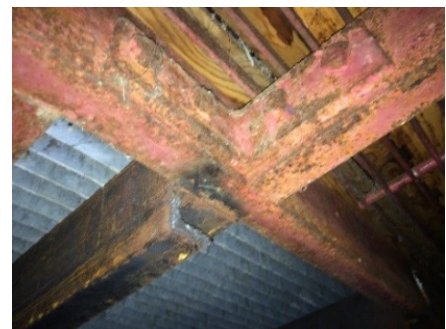
Image 12

The metal grating at the first floor level in the hose tower is deteriorating (Image 12) as evidenced by rusting, scaling, and light delamination.

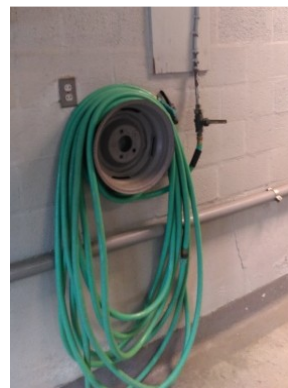
The hose connection in the Apparatus Bay does not include a required vacuum breaker. (Image 7)

Image 7 – Hose Connection

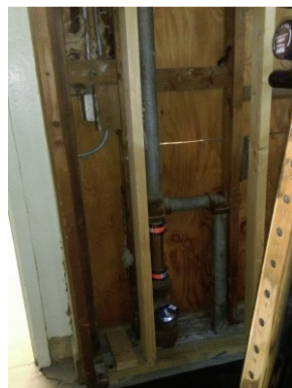
Sanitary, waste and vent piping is generally cast iron bell and spigot while there is evidence of galvanized steel vent piping throughout. Piping appears to be original and in fair to poor condition. There are floor drains in the Apparatus Bay, but there is no gas-oil separator on site. The entire building sanitary system is directed to Municipal sewer on street. (Image 11, Image 12)

Image 11 – Waste & Vent Piping

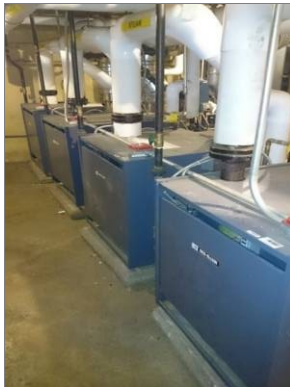
The building is heated by four (4) gas-fired cast iron sectional low pressure steam boilers (*Image 1*). The boilers were manufactured by Weil-McLain (Model EG/PEG-65, 157 MBH output for steam, 250 MBH max input). The boilers appear to be in good condition. The boilers appear to have been manufactured within the last 10 years and would be expected to have approximately 20 more years of serviceable life. Each boiler has a ducted 6" diameter B-vent duct connection (*Image 2*) into the chimney. The boilers have a low operating efficiency due to being high mass cast iron sectional type in comparison to today's high efficiency boiler systems.

Image 1 – Boilers

- **Heating System:** The existing low pressure steam boilers are inefficient in comparison to today's energy efficient boilers. We recommend that the existing boilers are replaced with a high efficiency gas-fired condensing hot water boiler plant, consisting of high efficiency gas-fired condensing boiler, pumps equipped with VFD drives (or ECM motors), DDC controls (including outdoor air reset), and accessories. All new steel/copper mains distribution system should be provided to replace the existing main low pressure steam piping and hot water piping mains.
- **Ventilation:** We recommend mechanical ventilation to be installed providing code compliant ventilation throughout the fire station. Outside air could be introduced and improve overall indoor air quality throughout the building.

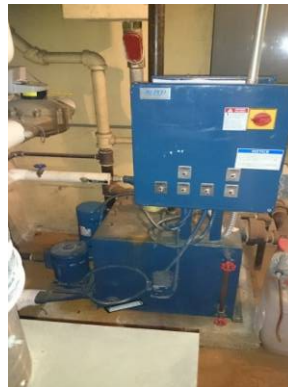
The Boiler Plant has one condensate receiver pump system that serves all the boilers. The Condensate receiver (*Image 3*) was manufactured by Mepco manufactured approximately in 2008 Model number VD630 2E. The condensate receiver has two (2) ½ horsepower motors and appears to be in fair condition and could be expected to have approximately 13 more years of serviceable life.

Image 3 – Condensate Receiver

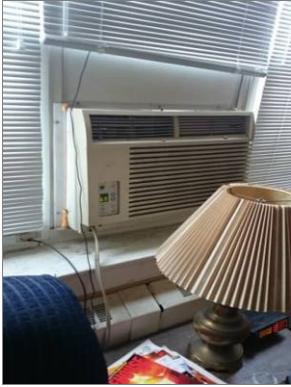
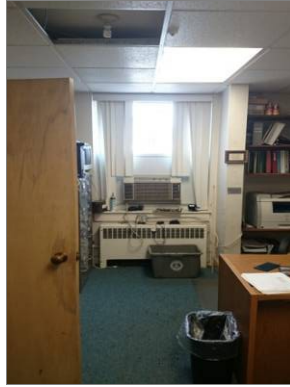
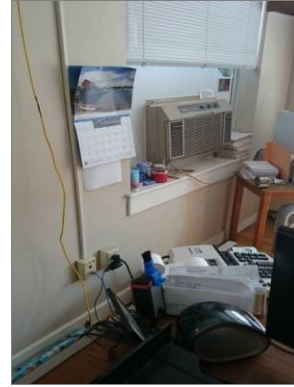
There is no central air conditioning in the Fire Station. Through wall air conditioning units are throughout the fire station located in windows and wall penetrations. The age of the air conditioners throughout the station vary, but largely most appear toward the end of their serviceable life expectancy. (*Image 5*) (*Image 6*) (*Image 7*)

Image 5 – Typical Window AC

Image 6 – Typical Window AC & Convactor

Image 7 – Typical Window AC

- Air Conditioning: We recommend that a new high efficiency air conditioning system(s) be installed in areas that required air conditioning. The replacement system should could be a central system also providing ventilation and replace the wall mounted air conditioning units. A new system would be recommended for the building that could meet the cooling load requirements of the building and improve overall thermal comfort.

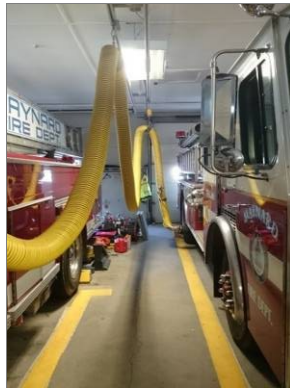
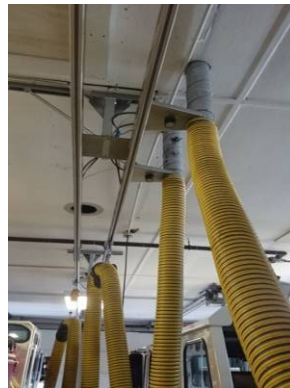
A vehicle exhaust air capture system is installed in the apparatus bay. The system is manufactured by Plymovent (Image 9) (Image 10), and consists of vent-set exhaust fan (Image 8) and filter unit located in the apparatus bay that is ducted to vehicle exhaust hose ductwork in the attic above the apparatus bay and the building exterior by a galvanized steel sheetmetal distribution system. In general, the vehicle exhaust air system appears to be in fair condition. Two gas fired unit heaters (Image 11) serve the apparatus Bay. The apparatus bay unit heaters appear to be in fair condition and should still have approximately 5-10 years of useful service life.

Image 9 – Apparatus Bay PlymoVent System

Image 10 – Apparatus Bay PlymoVent System

- The apparatus bay vehicle exhaust air system appears to be in good condition. The system fan and ductwork distribution system would be recommended to be tested to ensure it can be re-used. It is recommended that the system be fully tested, repaired as required, and maintained in accordance with manufacturers' recommendations.

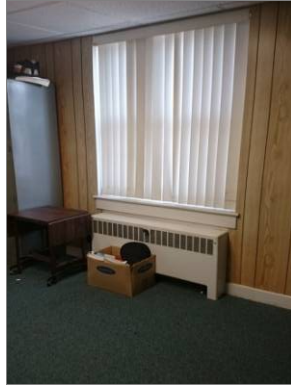
The kitchen has a residential style kitchen recirculation hood located over the combination stove/oven. The spaces have low pressure steam floor mounted convectors located throughout. The convectors appear to be in fair condition but would be recommended to be replaced due to the age of the equipment. (Image 12) (Image 13)

*Image 12 – Typical
Convector*

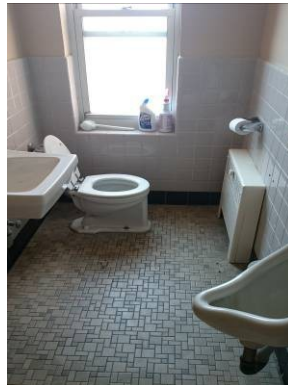
There is no mechanical exhaust system for the bath or toilet rooms. Operable windows provide natural ventilation to these spaces. Floor mounted convectors (Image 14) are located in the bathrooms on the main level while exposed uncased fin tube radiation bare element is run under the storage rack in the large gang toile on the second floor off the living quarters. The convectors and fine tube bare element appear to be in fair condition but would be recommended to be replaced due to the age of the equipment.

*Image 14 – Toilet Room
Convector*

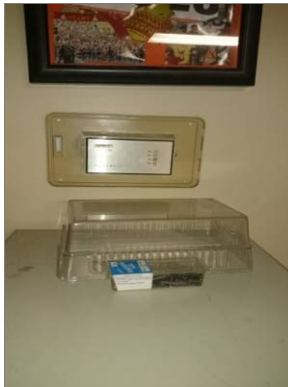
All of the controls in the building are stand-alone non-programmable. The controls are in poor condition and would be recommended to be completely replaced. (Image 18)

Image 18 – Thermostats

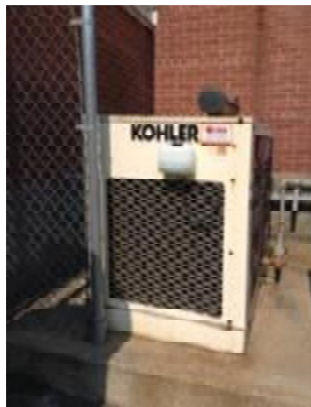
The generator and transfer switch were manufactured by Kohler and are in poor condition, are not code compliant, and are not suitable for reuse under a renovation program.

Image 6 – Generator

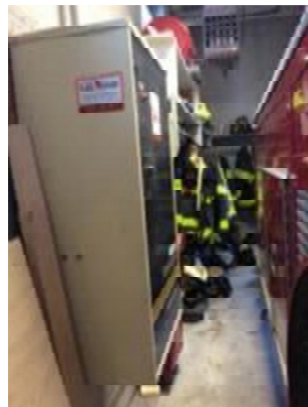
A 225 Amp, 120/240Volt, automatic transfer switch with two poles is located in the Apparatus Bay. The switch does not have the proper working clearance when the fire apparatus is in the bay. (Image 7)

Image 7 – Transfer Switch

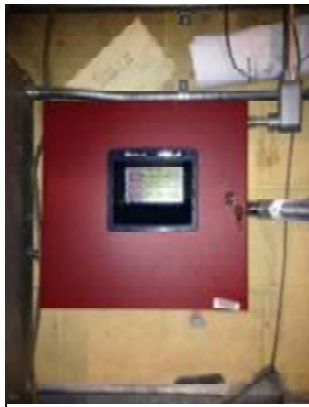
The fire alarm system provides inadequate coverage, does not meet code, and is not ADA compliant.

Image 8 – FACP

The fire alarm system should be replaced under a renovation program.
