Maynard Fire Station
Existing Conditions Assessment
Civil

October 12, 2015

CIVIL ASSESSMENT

Maynard Fire Station
Existing Conditions Assessment
Structural

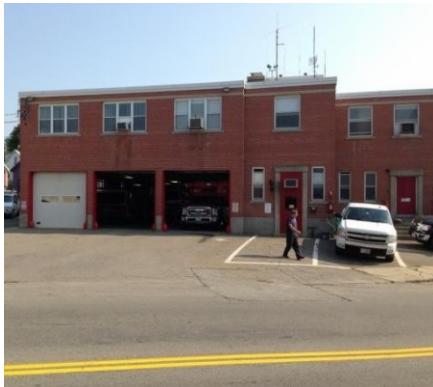
Image 1: West Face of Fire Station Building

The fire station garage has 3 doors for emergency vehicles on the west side of the building. Access to these garage doors is provided by a three lane driveway entrance on Summer Street (image 1). The fire station garage also has one emergency vehicle entrance on the northeast side of the building. Access to this garage door is provided by a one lane driveway entrance on Acton Street.

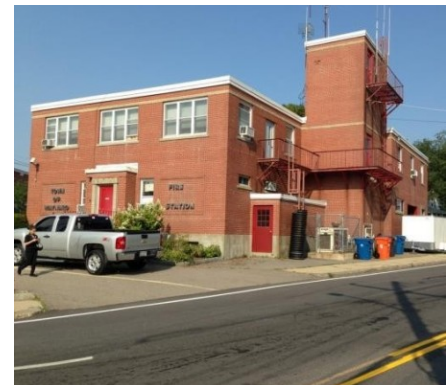
Image 2: East Face of Fire Station Building

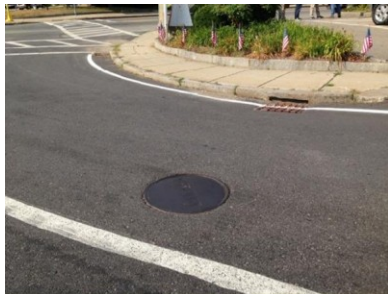
The parking lots and driveways are sloped to direct flow to the adjacent streets. The runoff flow on the east side of the site is directed to Acton Street, while the runoff flow on the west side of the site is directed to Summer Street. Both flows are then directed to the nearest three catch basins that are located at the intersection of Acton Street and Summer Street (images 3–5).

Image 3: Drainage Manhole and Catch Basin in Acton St

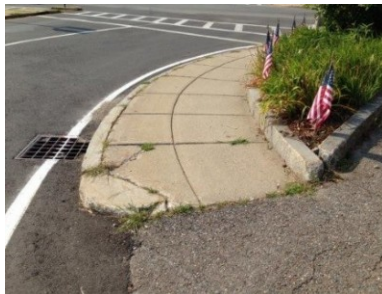
Image 4: Drainage Manhole and Catch Basin in Summer St

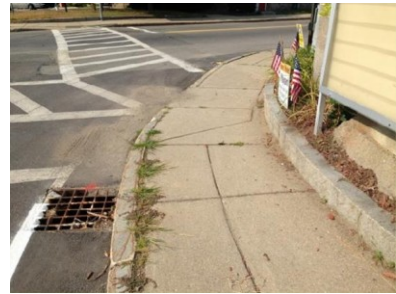
Image 5: Drainage Manhole & Catch Basin in Intersection of Summer St & Acton St

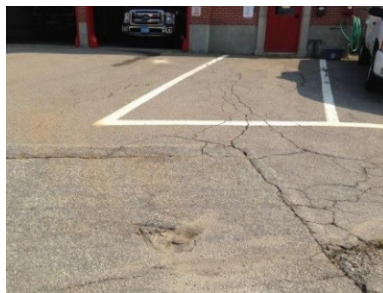
There are no record drawings of the existing water infrastructure. What is believed to be a water valve cap was observed during the site visit (image 6). There are two outside water spigots on the side of the building, one on the southwest face and the other on the northeast face (image 7). There are no fire hydrants located directly off the property.

Image 6: Water Valve Cover

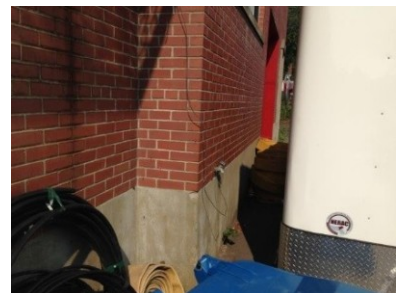
Image 7: Outside Water Spigot

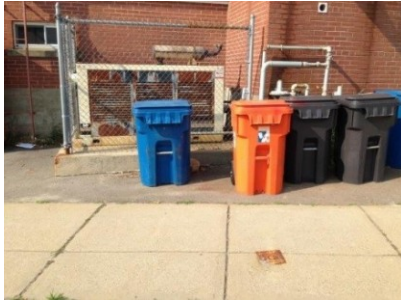
A Kohler Power System natural gas generator (image 9) located on the east side of the building was observed during the site visit. A gas cover (image 8) was observed on the sidewalk adjacent to the generator. It is possible that there is a gas line along Acton Street, although this could not be confirmed.

Image 8: Gas Cover

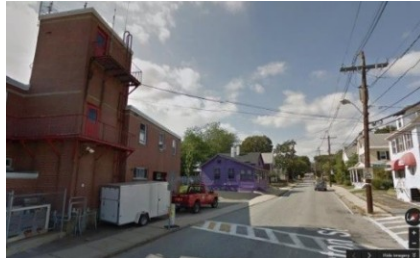
Image 10: Overhead Wires
(Image from Google Maps)

Overhead wires connecting to a utility pole along Acton Street were observed along the northeast part of the site connecting to the third floor tower of the fire station (image 10).

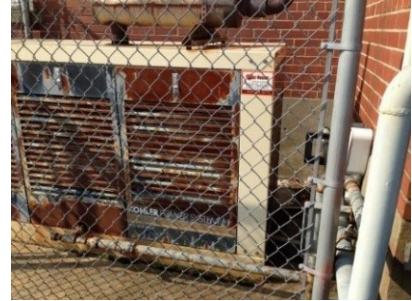
Image 9: Gas Generator

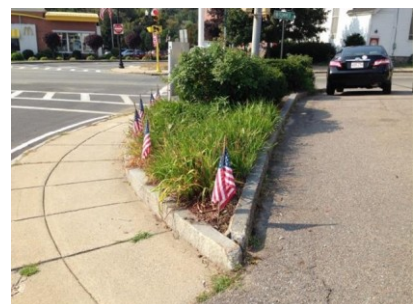
The asphalt pavement within the site is in generally poor condition with many areas of cracking and degradation (Image 11 and Image 12). There is vegetation that is coming through the cracks in many areas. Curbing on the site is of vertical concrete curb. Curbing is in general fair condition (image 13). No areas of ponding were detected during the site visit.

Image 13: Vertical Granite Curbing

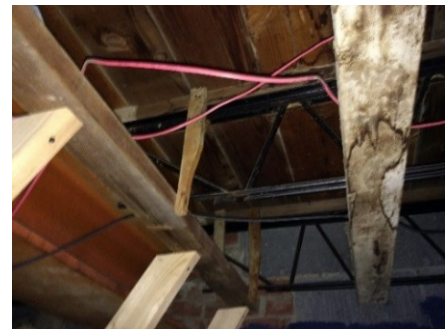
Image 11

The floor construction consists of wood plank decking on open web metal joists (Image 11) spanning between structural steel beams and masonry bearing walls.

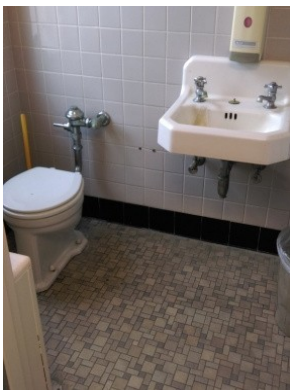
Water closets are floor mounted, vitreous china with exposed manual flush valves. *(Image 1)*

Lavatories are wall-mounted vitreous china with individual hot and cold handle faucets or 4"centers, single lever faucets. *(Image 1)*

Image 1 – Water Closet & Lavatory

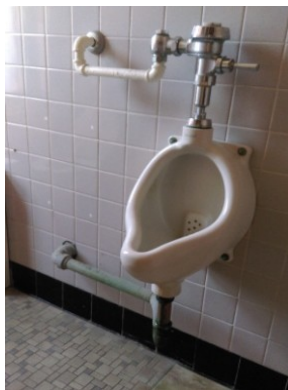
Urinals are wall hung vitreous china, with exposed manual flush valves. *(Image 2)*

Image 2 - Wall Mounted Urinal

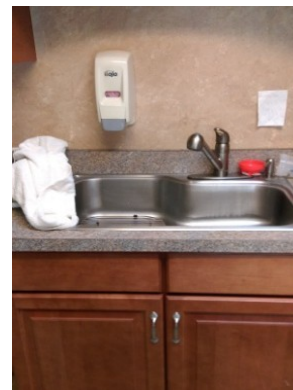
Kitchen sink is double bowl, counter mounted, stainless steel and deck mounted, single lever faucet with pull-out vegetable spray. *(Image 3)*

Image 3 - Kitchen Sink

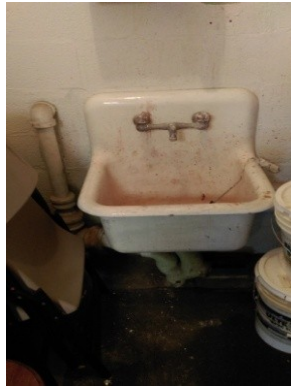
Janitor's sink is a wall mounted, cast iron sink with wall mount faucet. Faucet is equipped with vacuum breaker. *(Image 4)*

Image 4 – Service Sink

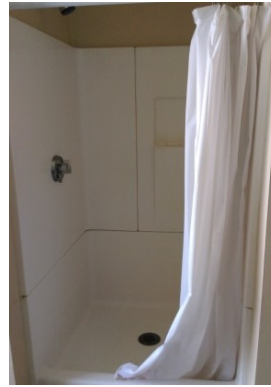
Showers are fiberglass units with single handle mixing valve and a fixed shower head. *(Image 5)*

Image 5 - Shower

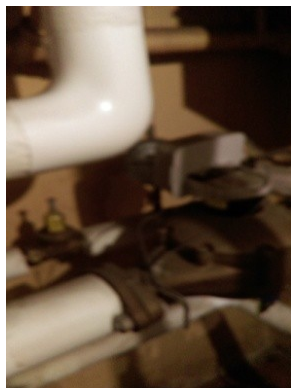
The water service enters the building in the Mechanical Room located in the Basement. Water service is 2" in size and includes a 1-1/2" water meter. (Image 6)

Image 6 – Domestic Water Service
& Meter

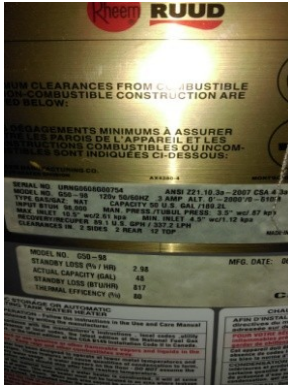
The main building hot water is generated through gas fired, 50 gallon hot water storage type water heater. The hot water system is not recirculated through the building. The system does have a mixing valve and an expansion tank. (Image 8, Image 9, Image 10)

Image 8 – Water Heater Information

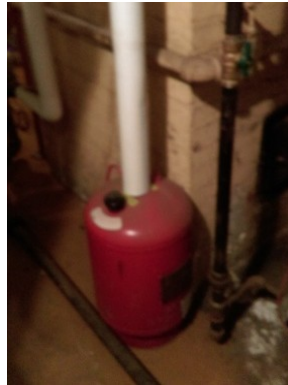
Image 9 – Expansion Tank

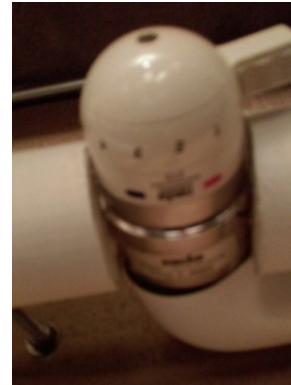
Image 10 – Mixing Valve

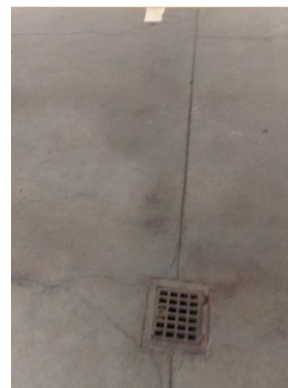
Sanitary, waste and vent piping is generally cast iron bell and spigot while there is evidence of galvanized steel vent piping throughout. Piping appears to be original and in fair to poor condition. There are floor drains in the Apparatus Bay, but there is no gas-oil separator on site. The entire building sanitary system is directed to Municipal sewer on street. (Image 11, Image 12)

Image 12 – Apparatus Bay
Floor Drains

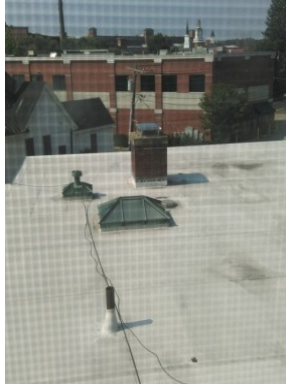
Roof drains consist of retro fit type, 4" pipe outlet with hexagonal strainers. Horizontal drainage piping does not appear to be insulated. (Image 13)

Image 13 – Roof Drain/Vents thru Roof

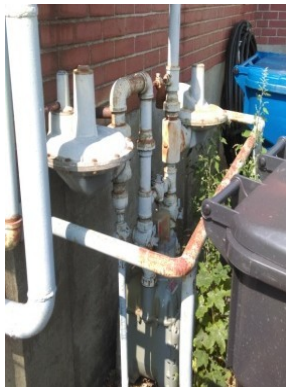
Natural gas is provided to the building. Gas service is a 1" elevated pressure line. At service location, a gas pressure regulator and gas meter is installed with an additional gas pressure regulator on the outlet side of meter. Gas supplies the heating boilers, domestic water heater, gas-fired unit heaters in Apparatus Bay and an emergency generator. There is a dedicated 2" gas line from the gas meter to the emergency generator and a 2-1/2" gas line with welded fittings to the building equipment. (Image 14)

Image 14 – Gas Service and Meter

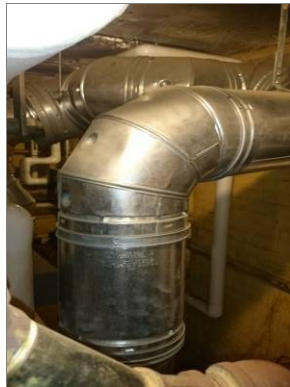
Image 2 – Boiler Vent

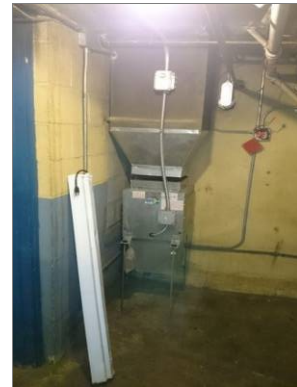
Combustion air (*Image 4*) is introduced from a fan assisted system in the corner of the room with open end ductwork to providing combustion air on a call from the boilers.

Image 4 – Combustion Air

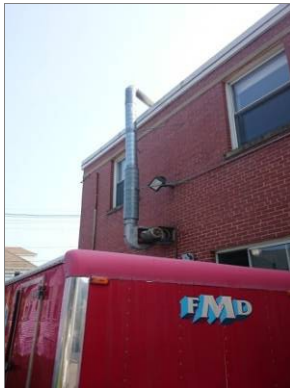
A vehicle exhaust air capture system is installed in the apparatus bay. The system is manufactured by Plymovent (Image 9) (Image 10), and consists of vent-set exhaust fan (Image 8) and filter unit located in the apparatus bay that is ducted to vehicle exhaust hose ductwork in the attic above the apparatus bay and the building exterior by a galvanized steel sheetmetal distribution system. In general, the vehicle exhaust air system appears to be in fair condition. Two gas fired unit heaters (Image 11) serve the apparatus Bay. The apparatus bay unit heaters appear to be in fair condition and should still have approximately 5-10 years of useful service life.

Image 8 – Apparatus Bay Sidewall Exhaust Fan

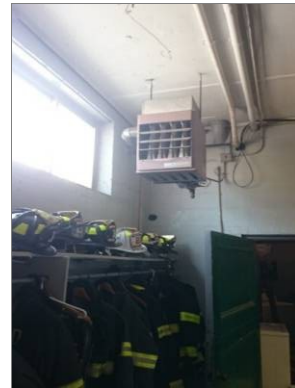
Image 11 – Apparatus Bay Unit Heater

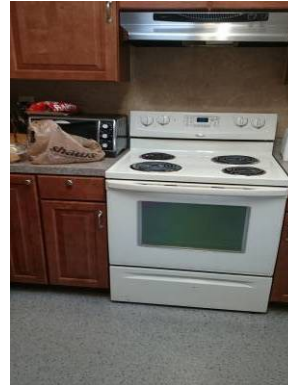
*Image 13 – Residential
Recirculating Hood*

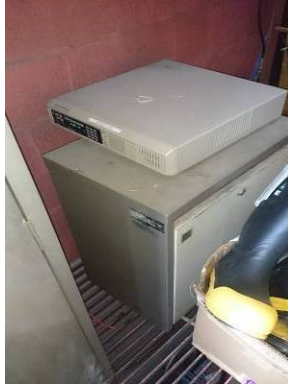
Image 15 – Electrical Equipment in Tower

The tower is open to the apparatus bay and rises higher than the second floor. There appears to be minimal heat in the tower. There is some computer and radio equipment located in the tower. (Image 15)

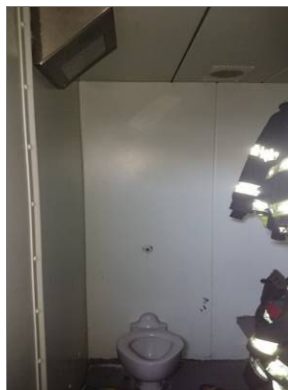
Image 16 – Cells

The Detention Area has ceiling mounted exhaust grilles. These grilles are ducted out of the Detention Area and into an open end duct in the adjacent room. This area is currently used for equipment storage. (Image 16)

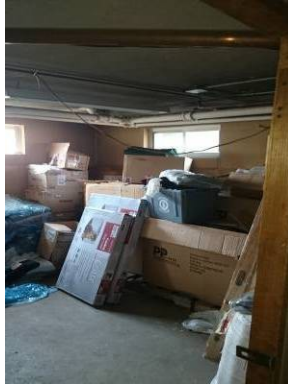
Image 17 – Basement Storage

The majority of the basement area is used only for storage area. There does not appear to be many terminal heating units downstairs. Operable windows would provide the only source of natural ventilation. (Image 17)

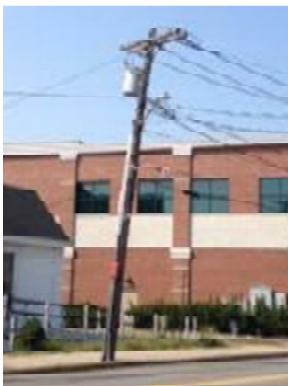
Image 1 – Primary Pole

Three phase overhead primary service runs on Summer Street and ends on last pole #92-2 across from the Fire Station. The Fire Station is fed with two secondary services; one rated at 150 Amperes, 120/240 Volt, 1 Phase, 3 Wire service and a second service rated at 100 Amperes, 240 Volt, 3 Phase, 3 Wire service. Both services run overhead between utility pole #92-2 and two meters located on exterior of the building. Service equipment for both services is located in the Apparatus Bay and appears original to the building and is in poor condition. *(Image 1, Image 2)*

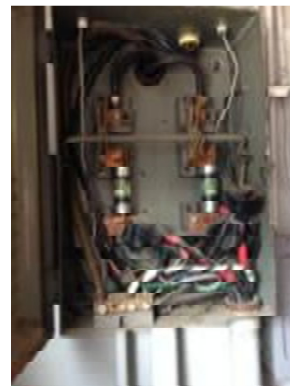
Image 3 – Single Phase Disconnect Switches

The switchgear consists of fused disconnect switches with multiple splices on load side of fuses, some without overcurrent protection for the tapped feeders. *(Image 3, Image 4)*

In general, switchgear for this facility is obsolete, in poor condition, and is not suitable for reuse during a renovation program.

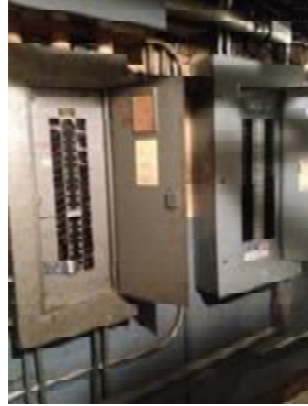
Image 5 – Panelboards

The three phase service feeds the plymovent and the compressors and is not backed-up by the generator. Services feed other remote panelboards of original vintage, as well as, other more recent panels. *(Image 5)*

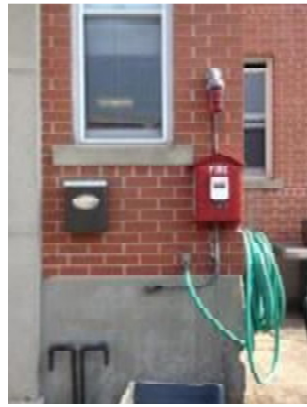
Image 9 – Master Box

The form of alarm transmission is via an exterior local energy master box with IMSA cable and via an AES radio box. Old style heats exist in Bunk Rooms, Basement and Apparatus Bay, could not locate heats in Boiler Room. *(Image 9)*

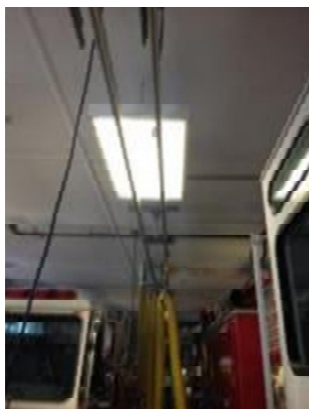
Image 10 – Apparatus Bay Light

The Apparatus Bay has 2x4 suspended troffers with six (6) T8 lamps in good condition. *(Image 10)*

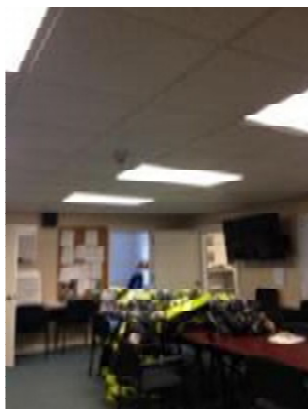
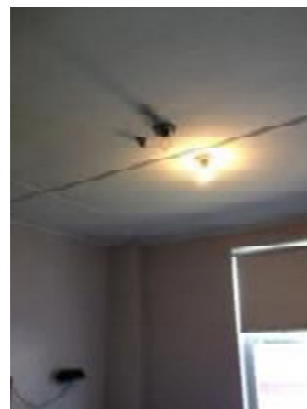
Second Floor Corridor, Day Room, and other areas generally have 2x2 & 2x4 recessed troffers with T8 lamps. Typical Bunk Room has a porcelain socket on a local switch, plus a second socket activated by incoming Alarms. *(Image 11, Image 12)*

Some porcelain sockets were left in place above the suspended acoustical ceilings when the ceilings were installed.

Most lighting fixtures are not suitable for reuse under a renovation program.

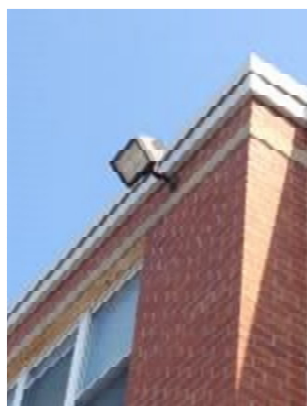
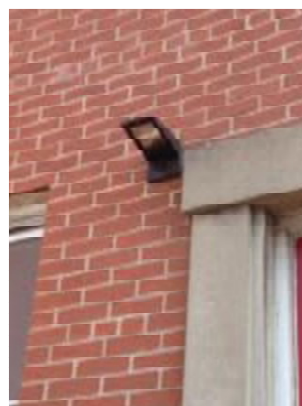
The exterior lighting consists of building mounted LED flood lights over overhead doors. An LED wall sconce is located over the entrance door. (Image 13, Image 14)

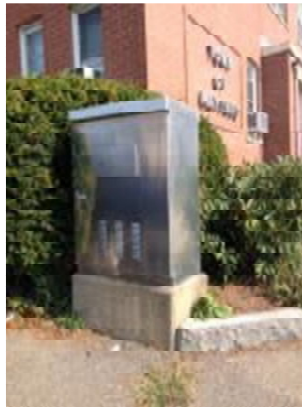
Image 15 – Traffic Light Cabinet

A traffic light NEMA 3R cabinet is located adjacent to the front of the Fire Station. The traffic light secondary service originates on pole 92/2 and runs underground in a 2" conduit to a meter mounted on the cabinet. (Image 15)
